**EMS Leak Detection Program
Registration RA05006
NW¼-35-042-25-W4M
Ponoka County, Alberta**

Report Date: June 12, 2020

Project Number: 2004-42875

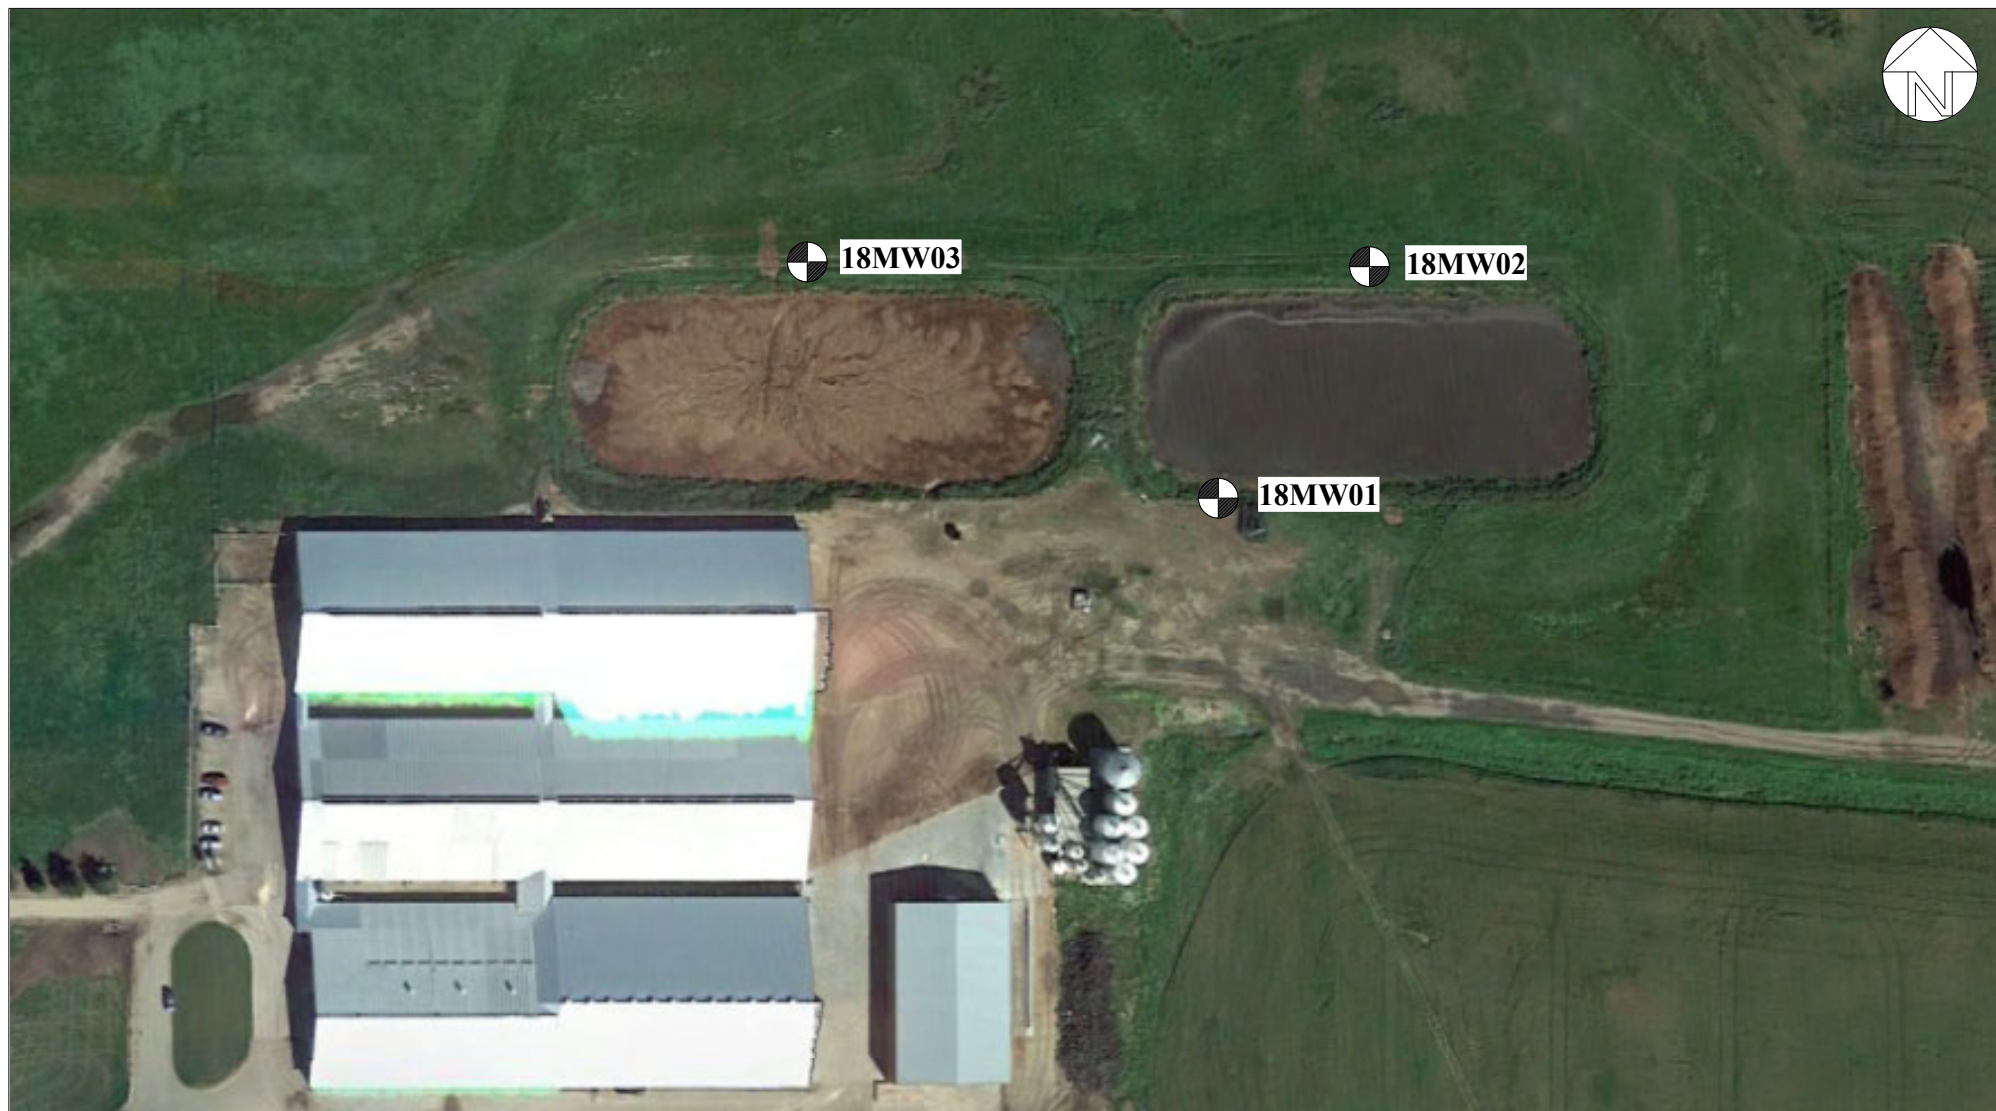
Figure:

A site map with approximate well locations is attached. There are three groundwater monitoring wells surrounding the manure storage lagoons, as shown on Figure 2.0. Envirowest drilled three boreholes with a truck-mounted rotary auger on July 30, 2018. The boreholes were completed between depths of 5.2 and 5.8 meters below ground surface (mbgs) and each borehole was completed as a groundwater monitoring well.
