RE: Response to NRCB Directive #CD25-04 on January 20, 2025

Southeast Catch Basin Clean-out and Management Plan:

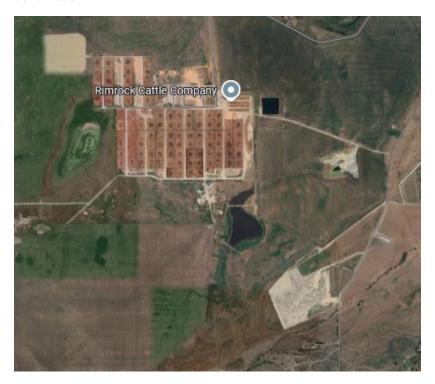
Google Maps – grassland and cultivated acres as shown on google maps below surrounding Rimrock Cattle to spread/irrigate contents from SE catch basin cell 1, 2 and swales feeding into the catch basin.

All cell 1, 2 and swale contents as part of clean-out and on-going management will be irrigated/spread on surrounding grasslands and cultivated acres. See google map attached.
