Compliance Directive

Directive #: CD 25-07

This directive relates to unauthorized construction of a manure storage facility (MSF) and manure collection areas (MCAs) at an existing dairy confined feeding operation (CFO) without a permit when a permit is required under the *Agricultural Operation Practices Act* (AOPA). The MSF consists of solid manure stockpiling and the MCAs consist of a calf/hay storage barn, a heifer barn, and a dry cow barn.

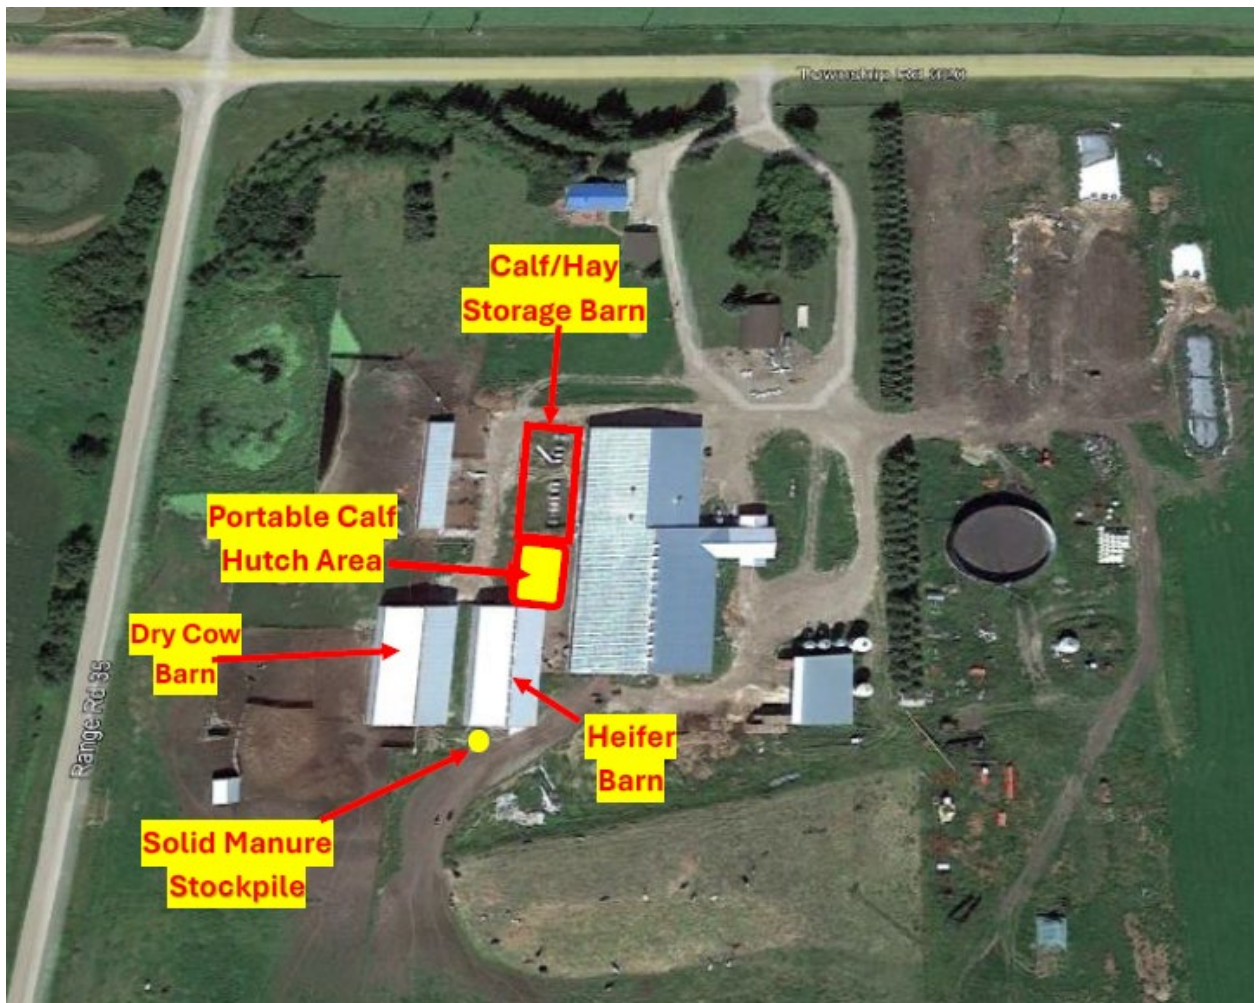
Appendix A – Google Earth Pro Aerial Imagery dated August 2022. Labelled by Inspector Tracey Krenn.

- Between the existing dairy barn and open face calf shelter was a newly constructed calf/hay storage barn that was not shown on aerial imagery from August of 2022. The front portion of the barn was currently being used to house and feed calves. The remainder of the barn was empty. The operator advised the remainder of the barn was to be used for hay storage. The floor of the barn was dirt which the operator advised consisted of clay. The operator advised the calf/hay storage barn was built last year, in 2024, to replace the portable calf hutches.

- Directly south of the new calf/hay storage barn was a fenced area that contained portable calf hutches. There was no livestock in this area at the time of inspection.

- Directly southwest of the calf/hay storage barn and directly south of the open face calf shelter was a newly constructed barn that the operator advised was used to house dry cows (occupied). The dry cow barn contained a concrete feed alley and freestalls. The floor of the freestall area was dirt which the operator advised consisted of clay. The operator advised he had built the barn over existing corrals. AO Lynn Stone advised that if that were the case, the barn could potentially be grandfathered.

- Located directly south of the calf/hay storage barn and portable calf hutch area, was another newly constructed barn which the operator advised was used as a heifer barn (occupied). This barn also had a concrete feed alley and freestalls. The operator advised the concrete alley extended 10 feet into the freestall area.

- Visible at the south end of the heifer barn was a solid manure stockpile. The operator advised that every time he cleans out the barns, he stockpiles manure at this location until it is spread.

1. By September 15, 2025, depopulate, remove all manure, and cease using the calf/hay storage barn (see Appendix A) for the purpose of housing livestock or manure storage, unless an NRCB permit for the use of the calf/hay barn as a manure collection area has been obtained.

2. By September 15, 2025, depopulate, remove all manure, and cease using the dry cow barn (see Appendix A) for the purpose of housing livestock or manure storage, unless an NRCB permit for the use of the dry cow barn as a manure collection area has been obtained.

3. By September 15, 2025, depopulate, remove all manure, and cease using the heifer barn (see Appendix A) for the purpose of housing livestock, unless an NRCB permit for the use of the heifer barn as a manure collection area has been obtained.

4. By September 15, 2025, remove the manure stockpile located at the south end of the heifer barn and not use that area until it meets the AOPA's requirements for short-term solid manure storage, unless an NRCB permit has been obtained for a manure storage facility.

5. Not repopulate the portable calf hutch area (see Appendix A) unless an NRCB permit has been obtained for the use of the portable calf hutch area as a manure collection area.
