Compliance Directive

Directive #: CD 25-11

This directive relates to unauthorized construction at Springer Dairy Ltd., which is a “deemed” dairy confined feeding operation (CFO). The unauthorized construction is in relation to the construction of a manure collection area (MCA) in the form of a “new feed alley” which replaced the “old feed alley,” and the construction of a manure storage facility (MSF) which is the conversion of the freshwater storage dugout to a MSF as characterized in the Google Earth site image (Appendix A), labelled by the operator on May 26, 2025.

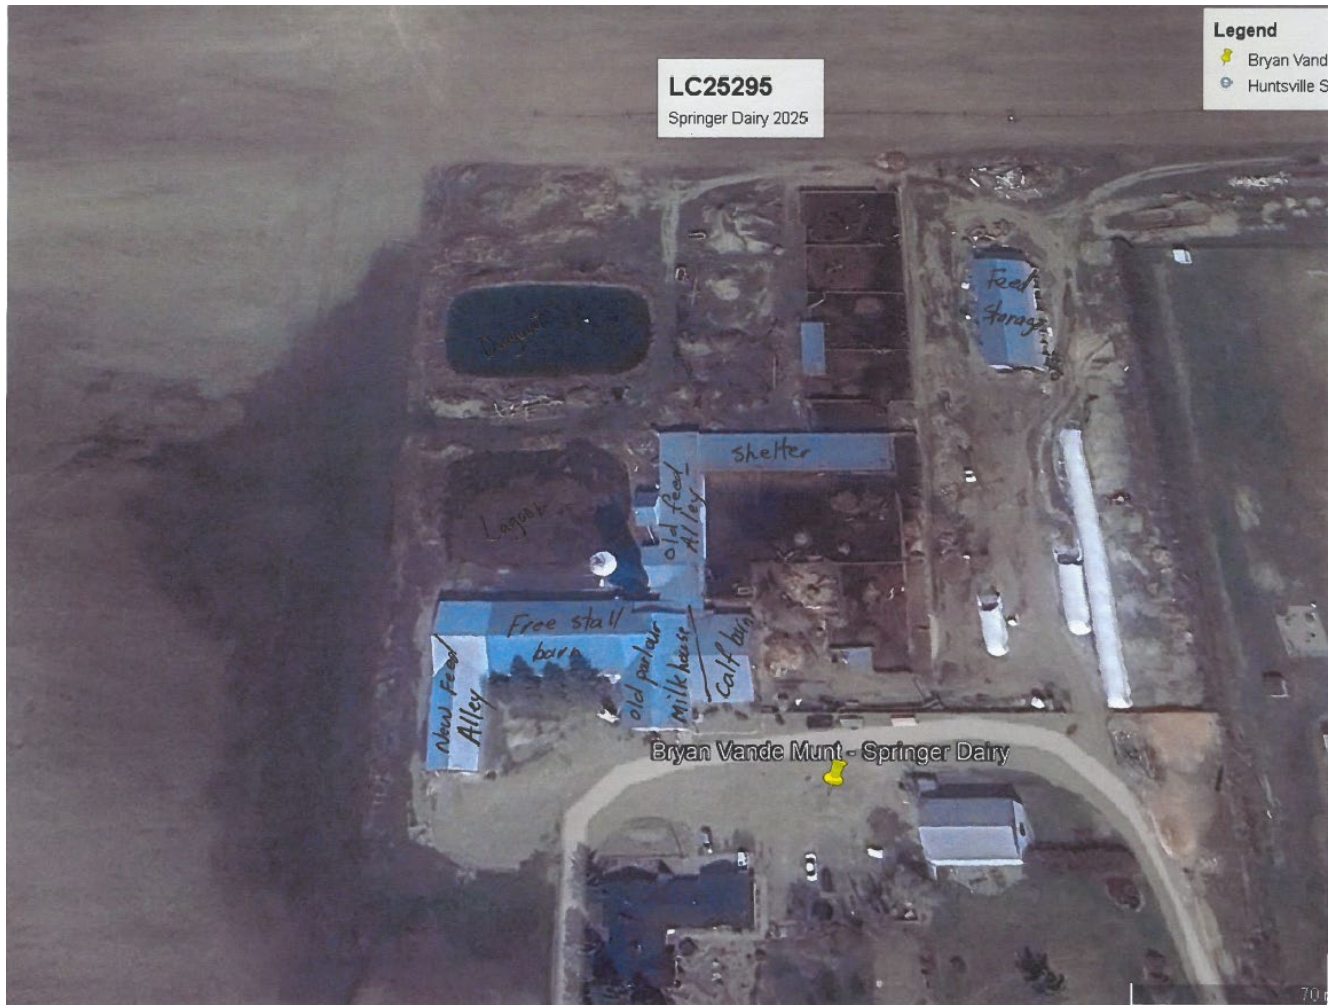
Appendix A: Google Earth Site Image (2025) labelled by Bryan Vande Munt on May 26, 2025

On May 26, 2025, I attended Springer Dairy and met Mr. Vande Munt onsite in front of the Milk house part of the main dairy barn. I presented Mr. Vande Munt with a printed Google Earth image of his operation and had Mr. Vande Munt label the site image with naming conventions for each area of the barn and the operation to understand the operation before commencing my inspection (Appendix A).

I also observed the current MSF is filled from an underground pit system within the main dairy barn that flows directly from the new feed alley/free stall barn (see Appendix A) via an outlet pipe into the converted MSF. Mr. Vande Munt indicated he switched uses of the previous freshwater storage dugout and the previous MSF because the converted MSF is directly behind the new feed alley building.

1. By October 10, 2025, depopulate, remove all manure, and cease using the new MCA” (new feed alley)” for the purpose of housing and feeding livestock or manure collection unless an NRCB permit for this facility under AOPA has been obtained.
2. By October 10, 2025, if an NRCB permit under AOPA has not been obtained for the MSF that was converted from a freshwater dugout to an MSF,
 - a. remove all manure and cease using the converted MSF as a liquid manure storage, and
 - b. submit a plan to the NRCB on how you will manage and store your liquid manure
3. By October 31, 2025, if an NRCB permit under AOPA has not been obtained for the MSF that was converted from a freshwater dugout to an MSF you must;
 - a. fully close the MSF, in accordance with Technical Guideline Agdex 096-90 Closure of Manure Storage Facilities and Manure Collection Areas.

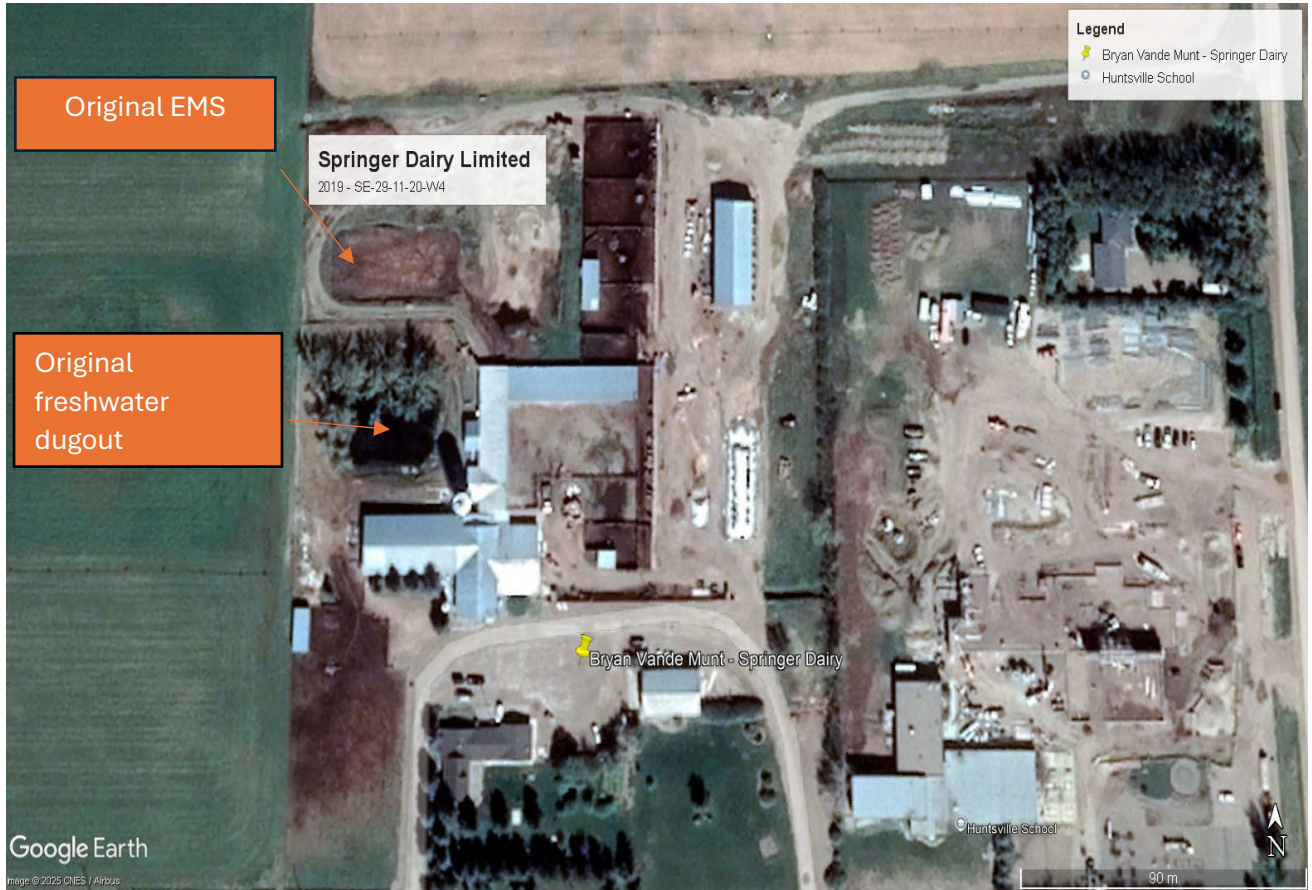
Appendix B: Google Earth Site Image from 2019 depicting the CFO

I identified the operation on the south ½ of SE-29-11-20-W4 bordering the west side of the Huntsville School in Iron Springs, Alberta. It was clear based on my search of the NRCB CFO Database this operation did not have any NRCB permits and in fact was not entered in the database as a confined feeding operation. After completing further reviews of aerial imagery using the Government of Alberta Geocortex web mapping tool website, it was clear the operation existed around January 1, 2002, and likely long before that based on the Geocortex Valtus imagery from 1999-2003. It appeared the operation remained mostly unchanged from 2003 until sometime between 2019 and 2022 where an addition was constructed on the southwest corner of the dairy barn.

It also appeared the operator reversed the usage of the freshwater storage dugout and the original MSF sometime between 2019 and 2022 (Appendix B and C). Google Earth imagery showed what appeared to be a MSF which was in existence since at least around the grandfathering time frame (January 1, 2002). However, between 2019 and 2022 some changes were made to what looked like a freshwater storage dugout directly south of the original MSF that was surrounded by trees. Between 2019 and 2022 the trees were levelled, and the usage of the freshwater storage dugout appeared to have changed to an MSF.

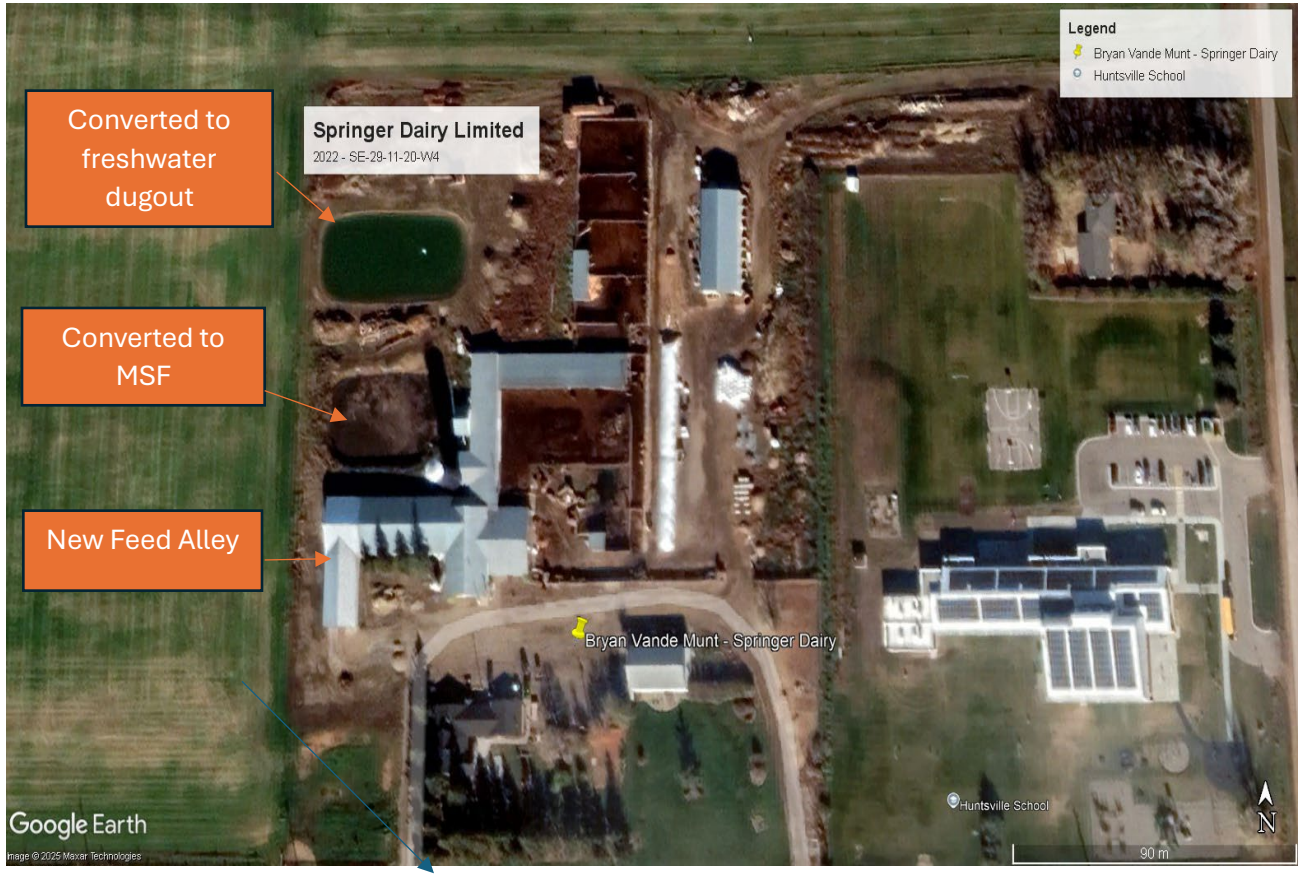
Appendix C: Google Earth Site Image from 2022 depicting unauthorized construction

Based on my observations, my conversations with Bryan Vande Munt of Springer Dairy Ltd., and my site inspection on May 26, 2025, I conclude that Bryan Vande Munt of Springer Dairy Ltd. contravened section 14 of AOPA for the reason that he constructed an MSF (converted water storage dugout to an MSF) and new feed alley (MCA) without first receiving an NRCB Permit authorizing that construction.
