# Compliance Directive

**Directive #:** CD 25-15

This directive relates to unauthorized construction at Hutterian Brethren Church of Wavy Lake, which is a multi-species confined feeding operation (CFO). The unauthorized construction is in relation to a manure storage facility (MSF), specifically a solid manure storage pad with a concrete floor, that has been constructed and is being used to store solid manure. In addition, the 45.7 m x 45.7 m x 2.4 m deep feedlot runoff control catch basin permitted by the NRCB in Approval RA05022 has not been properly maintained or managed, resulting in the catch basin contents overflowing.

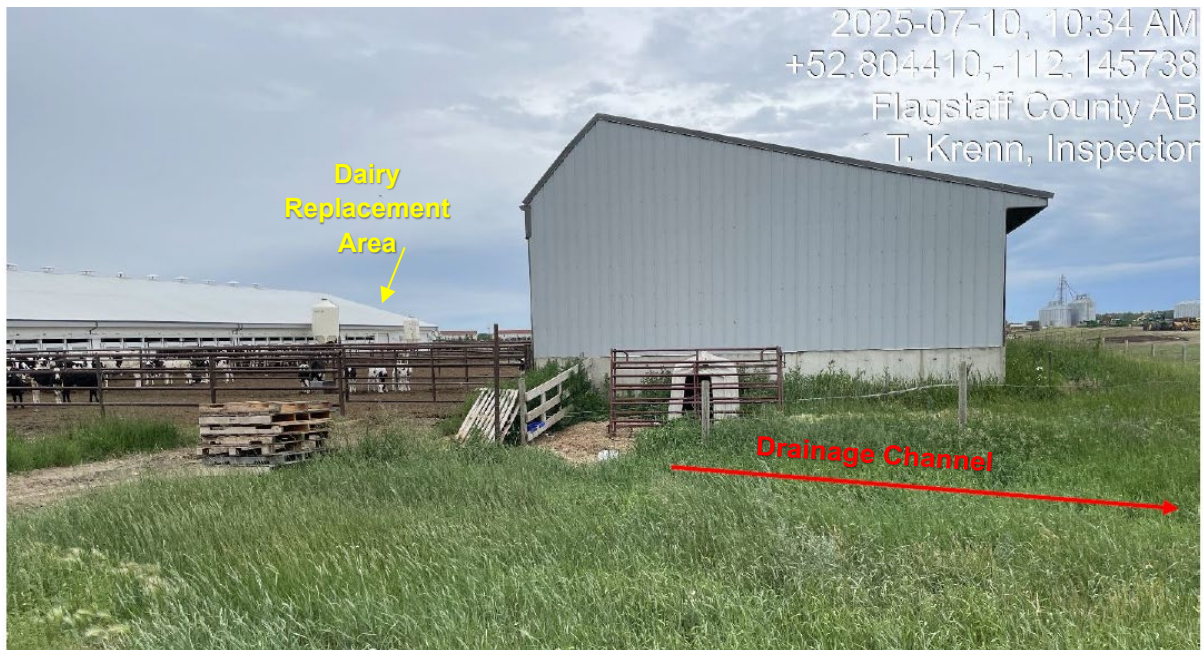
**Appendix D – Site Inspection Photos July 10, 2025 – Dairy replacement area and drainage channel**

wetland type of area. I asked Philip about the location of the catch basin and the feedlot the area. Philip advised the catch basin had always been located in the field to the north and received runoff from the dairy replacement area (occupied by dairy cattle). Philip advised runoff from the dairy replacement area travels via a drainage channel that runs along the east side of the dairy replacement area, through a culvert, then along the drainage channel to the north into the wetland type area (**Appendix D**). As I was unable to determine the exact location of the catch basin, located within the wetland type area, I was also unable to assess whether the physical integrity of the catch basin liner inside walls, bottom, outside walls, or top berm had been compromised due to potential erosion or damage resulting from the catch basin overflowing.

Looking west from the east side of the dairy replacement area at the drainage channel that runs from the dairy replacement area to the north

and
2. **By November 4, 2025**, empty the contents of the catch basin originally permitted in NRCB Approval RA05022, land apply the contents in accordance with the conditions of Approval RA05022A, and contact the NRCB to schedule a site inspection;

or
3. **By November 4, 2025**, obtain a NRCB permit for the construction a new catch basin for use in conjunction with the dairy replacement area originally permitted in Authorization RA08027.

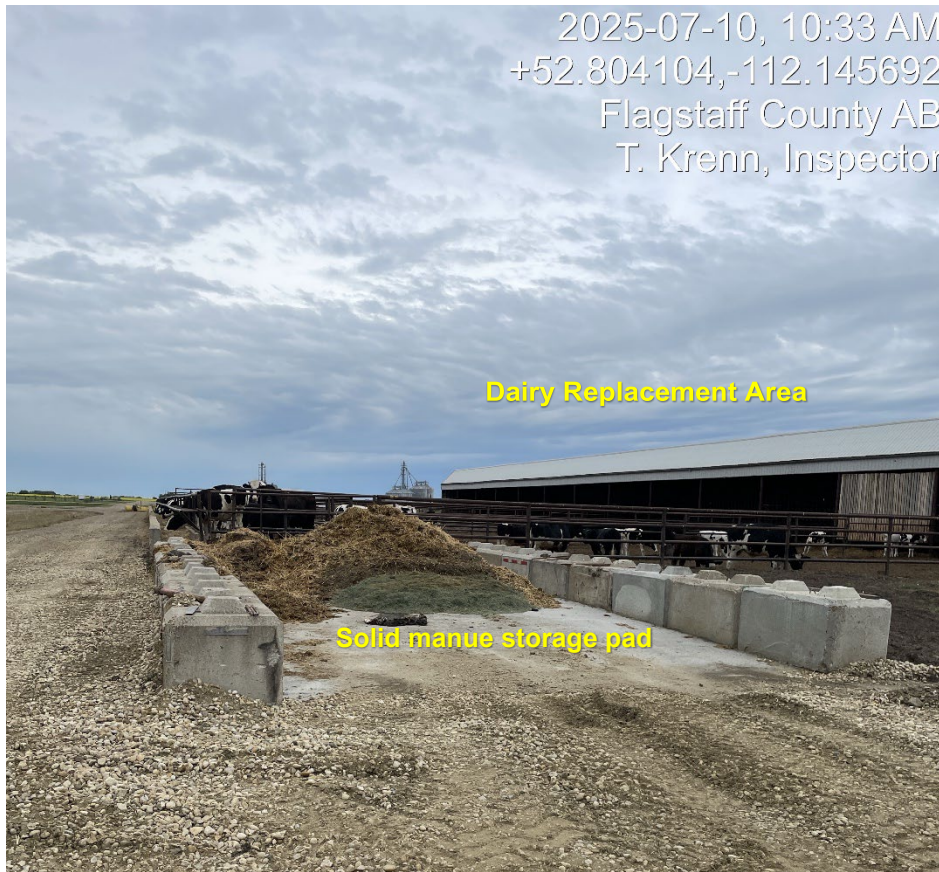
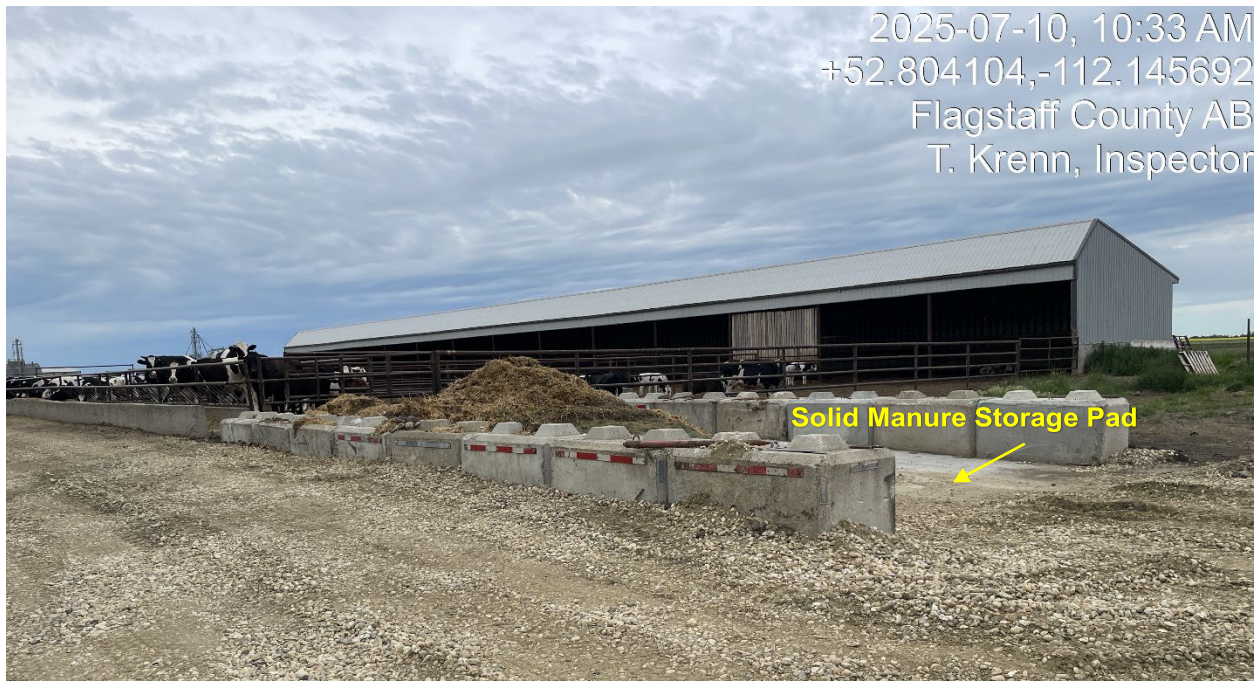
**Appendix E – Site Inspection Photos July 10, 2025 - Solid manure storage pad  
(Unauthorized Construction)**

A solid manure storage pad with a concrete floor (**Appendix E**) had been constructed just off the southeast corner of the pen area, which I later confirmed to be the dairy replacement area. Solid manure was currently being stored on the storage pad. I asked Philip if a permit had been obtained for the solid manure storage pad. He stated he didn't think so. I advised I had not seen a permit on file. I also advised that a permit was required for the solid manure storage pad and that it was considered unauthorized construction. I advised Philip that once I returned to the office, I would speak with an NRCB approval officer and then follow-up with him as to the next steps.

1. **By November 4, 2025**, if an NRCB permit under AOPA has not been obtained for the MSF, specifically the solid manure storage pad shown in Appendix E, you shall cease use of the MSF, remove all manure from the MSF, and close the MSF in accordance with Technical Guideline Agdex 096-90 [Closure of Manure Storage Facilities and Manure Collection Areas](#)
