Enforcement Order No. EO 25-04

*Made under section 39 of the
AGRICULTURAL OPERATION PRACTICES ACT, RSA 2000, c A-7 (AOPA)*

Basis for Order: Risk to the environment

2022 Leak Detection Monitoring Review Report
Westcoast Holsteins Ltd.
Authorization RA05006
NW 35-42-25 W4M

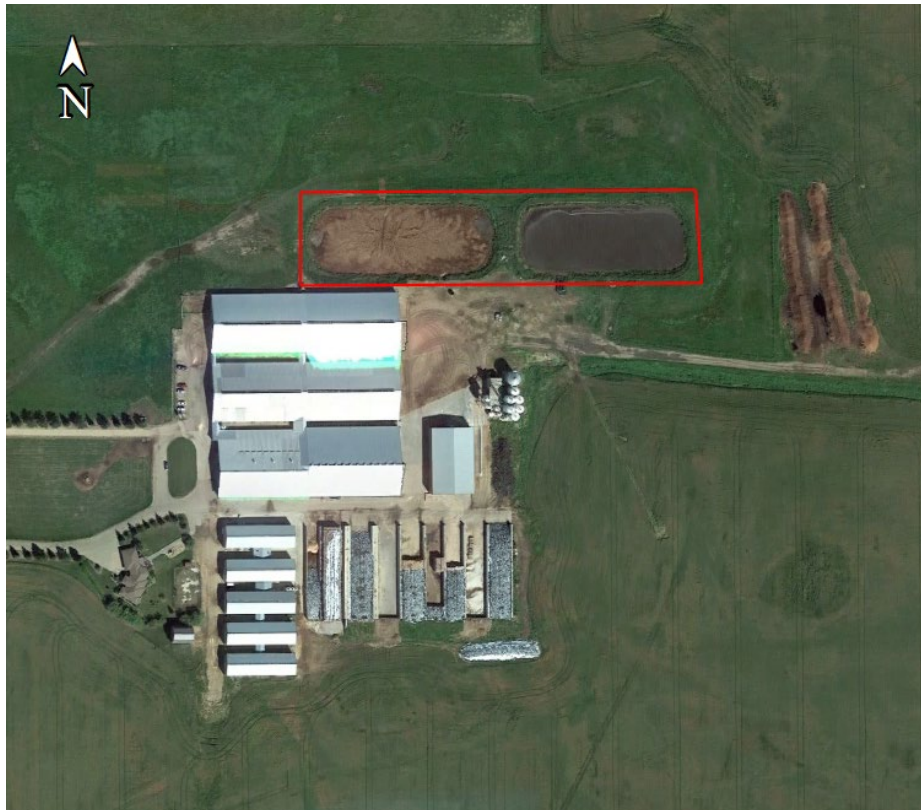
Figure 1. EMS at Westcoast Holsteins Ltd. The EMS is identified in the red box.¹

Westcoast Holsteins Ltd., located at NW 35-42-25 W4M (the Site) within Ponoka County, is a dairy confined feeding operation. Annual leak detection monitoring is required for the liquid earthen manure storage facility “EMS” or “facility” (as per Approval RA05006). The Site consists of an EMS (two cell) and other facilities associated with the operation (e.g. barns etc.). The EMS is located to the north of the dairy barns (Figure 1).

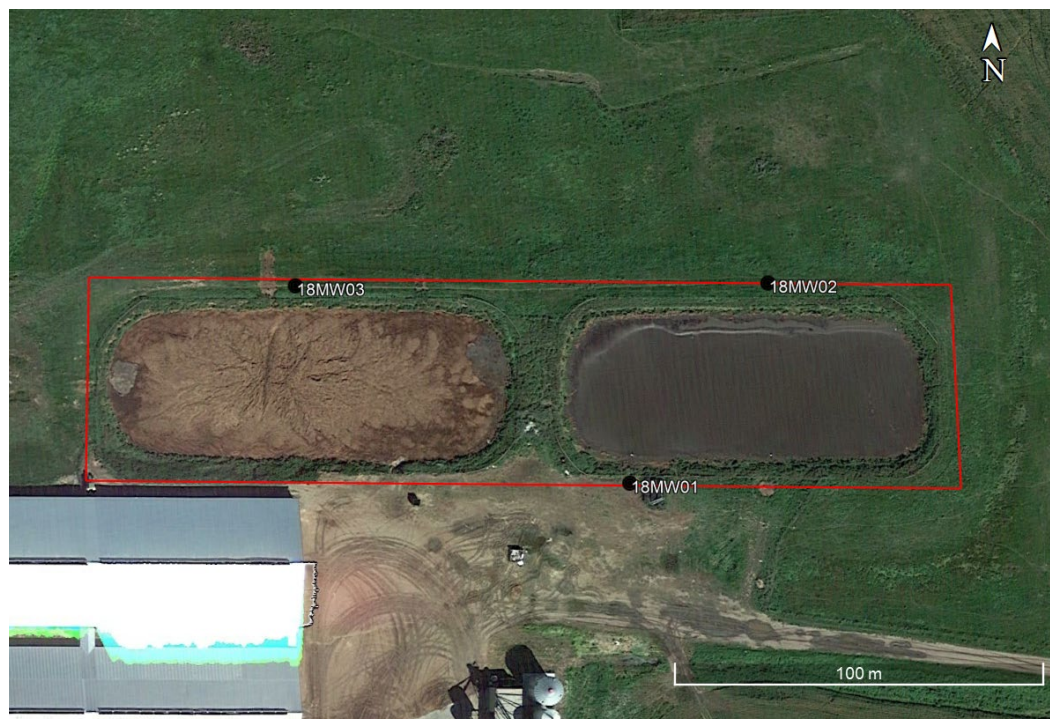
Figure 2. Monitoring well locations surrounding the EMS at the Site².

A leak detection monitoring system consisting of three groundwater monitoring wells was installed at the Site, with the monitoring wells requiring annual monitoring; groundwater monitoring wells were replaced in 2018 (Figure 2). The primary purpose of the leak detection monitoring system is to monitor the EMS.

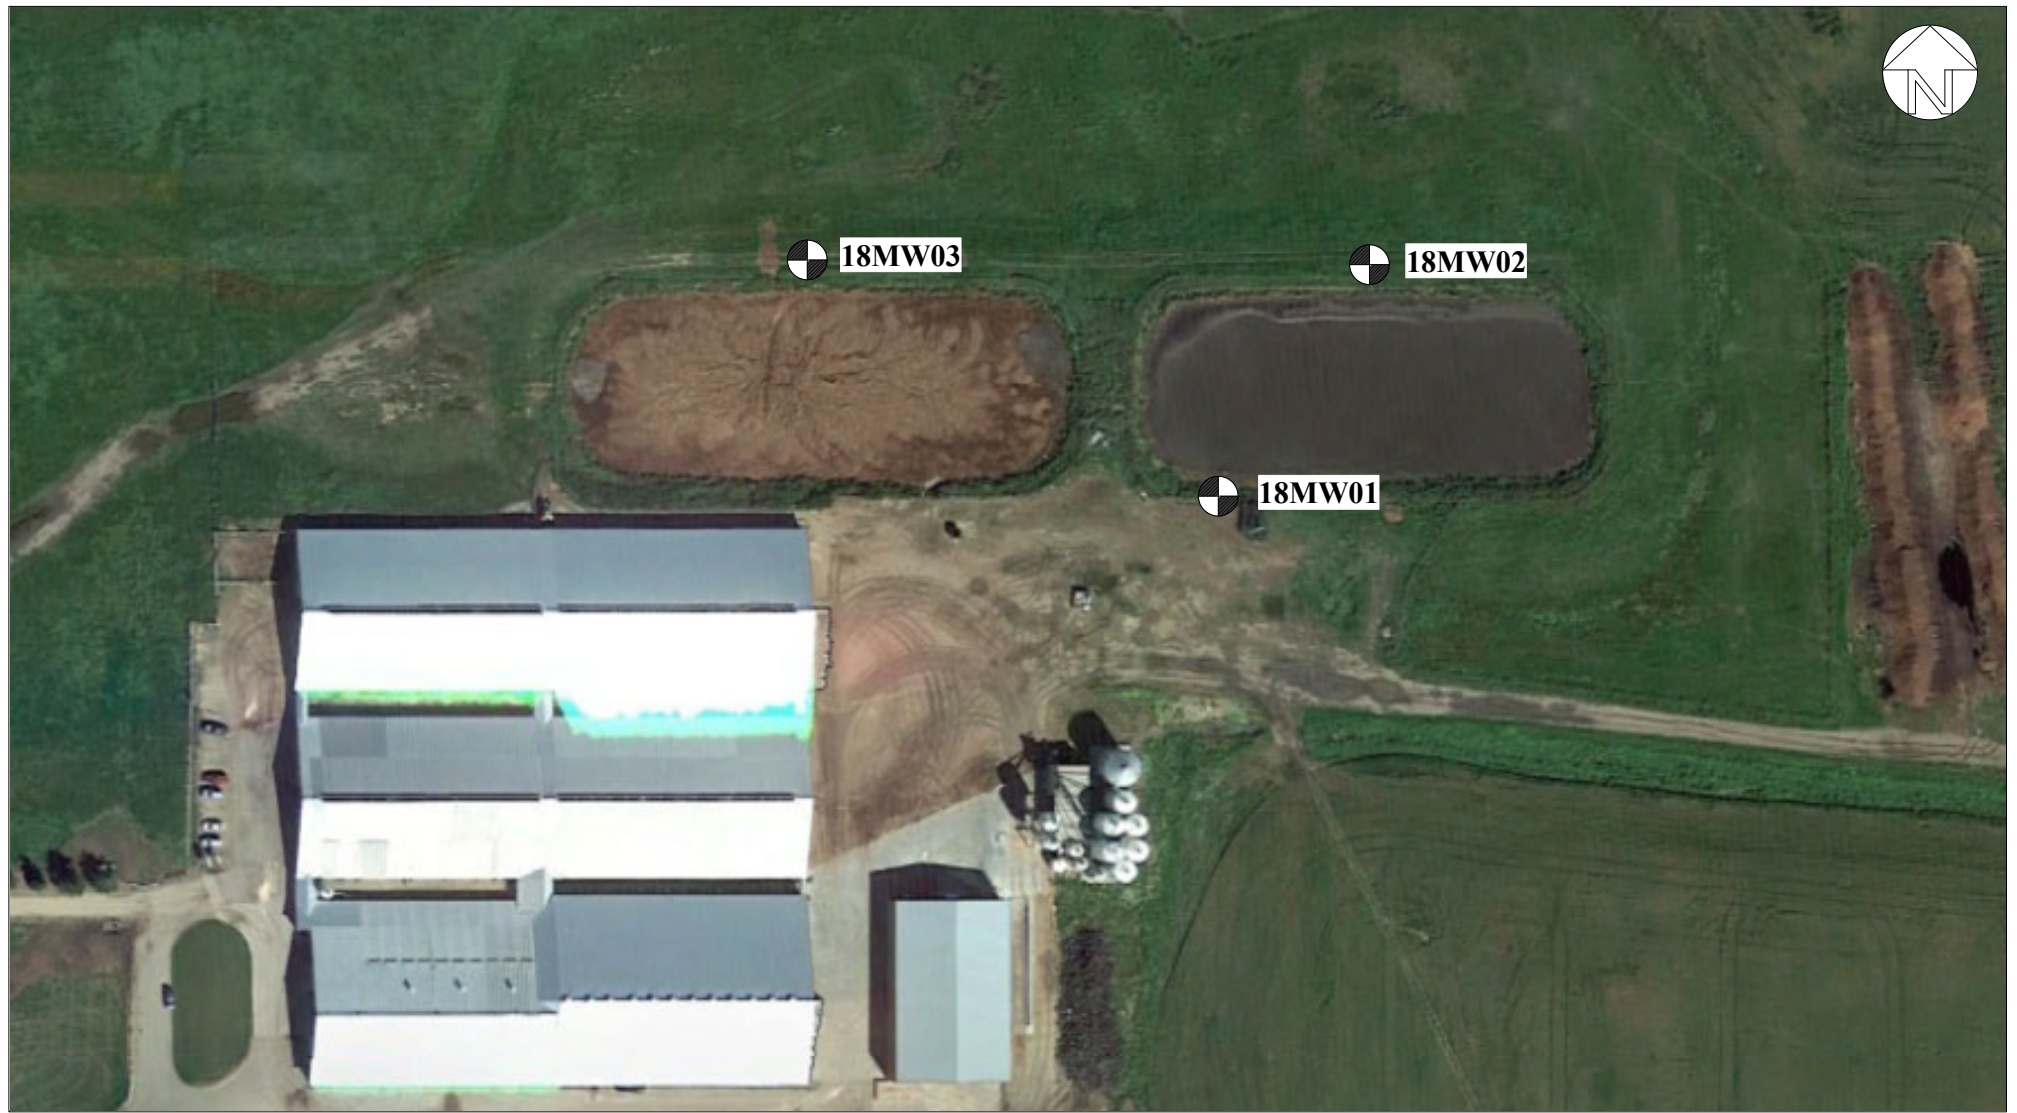
Title:

Monitoring Well Locations
Site and Soil Assessment
NW¼-Sec.35-Twp.042-Rge.25-W4M
Ponoka County, Alberta
