# Enforcement Order No. EO 25-04

*Made under section 39 of the  
AGRICULTURAL OPERATION PRACTICES ACT, RSA 2000, c A-7 (AOPA)*

**Westcoast Holsteins Ltd. and Ron Kooyman**

2022 Leak Detection Monitoring Review Report  
Westcoast Holsteins Ltd.  
Authorization RA05006  
NW 35-42-25 W4M

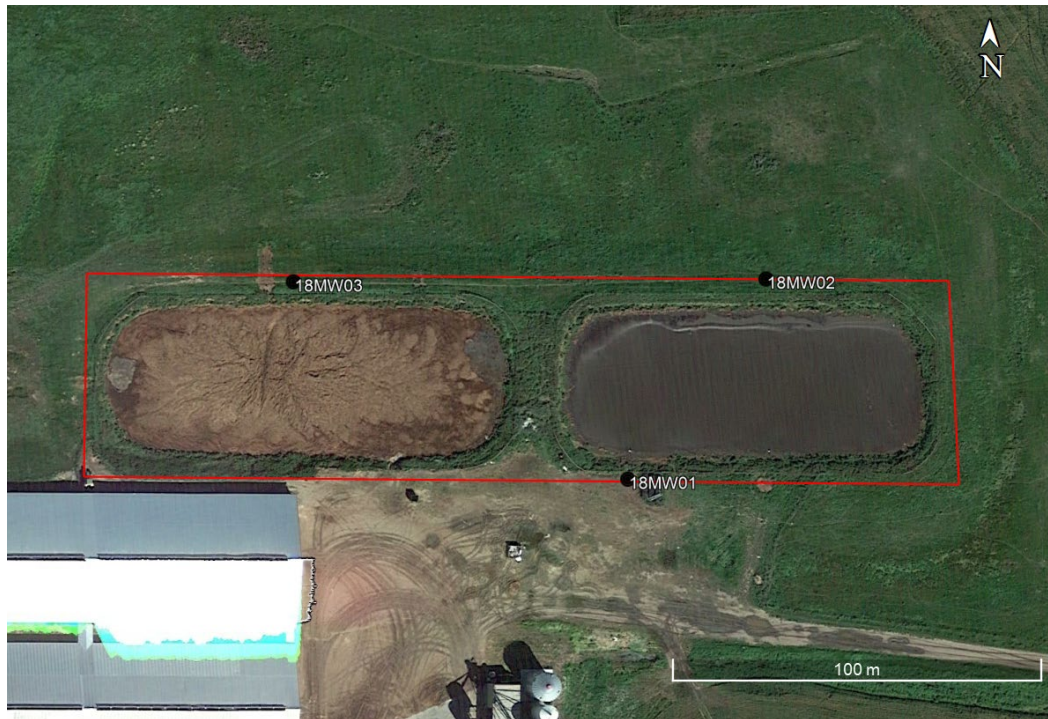
A leak detection monitoring system consisting of three groundwater monitoring wells was installed at the Site, with the monitoring wells requiring annual monitoring; groundwater monitoring wells were replaced in 2018 (Figure 2). The primary purpose of the leak detection monitoring system is to monitor the EMS.

Figure 2. Monitoring well locations surrounding the EMS at the Site<sup>2</sup>.
